2024 to 2025 Groundwater Monitoring Report

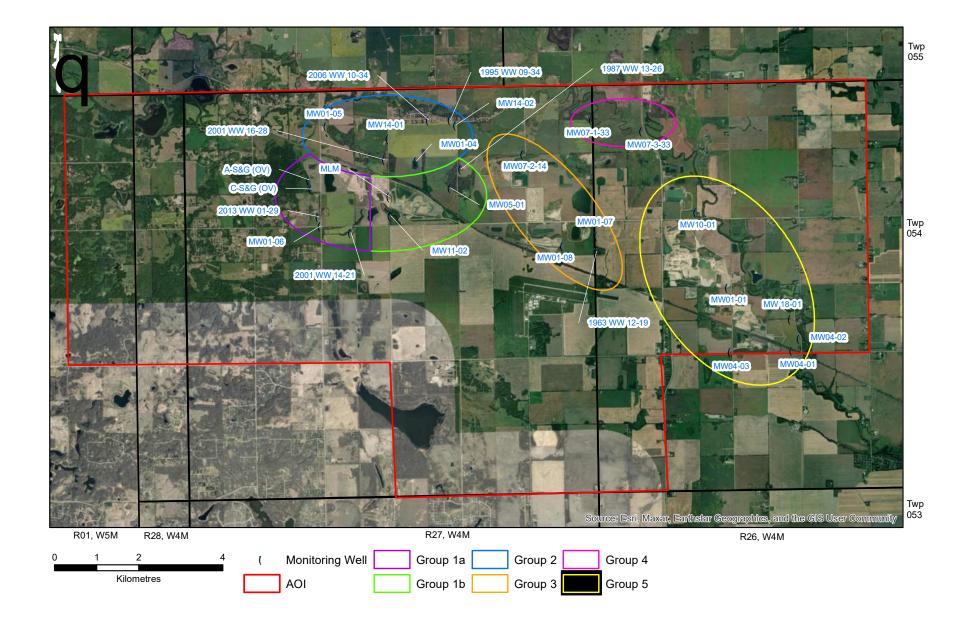
Water Levels Group 1a

Rising water-level trend in Group 1a monitoring wells beginning in 2019:

- A-S&G (OV)
- C-S&G (OV)
- MW01-06
- 2001 WW 14-21
- 2013 WW 01-29

The rise is attributed to this area being the farthest upgradient from recently dewatered sites

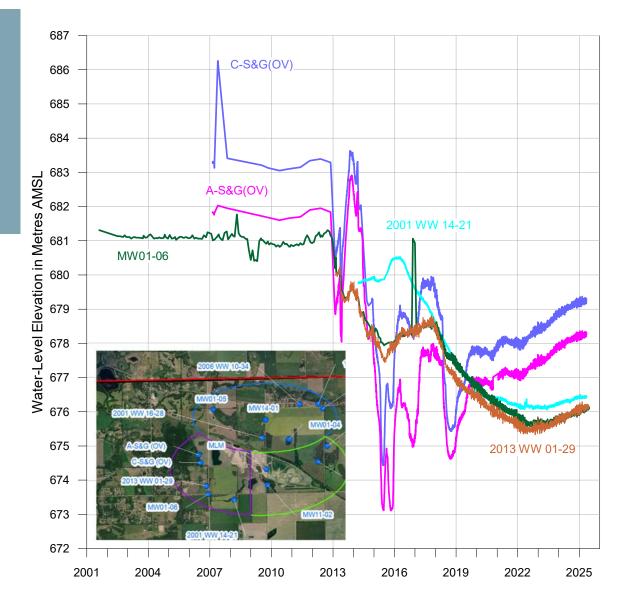
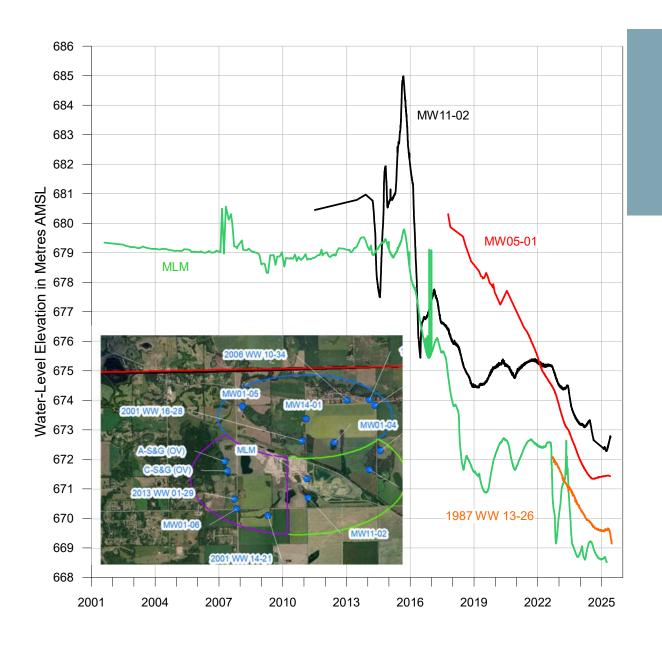
Water Levels Group 1B

Monitoring wells in Group 1b continue to show a declining trend:

- MLM
- MW05-01
- MW11-02
- 1987 WW 13-26

These monitoring wells are closest to recently dewatered sites.

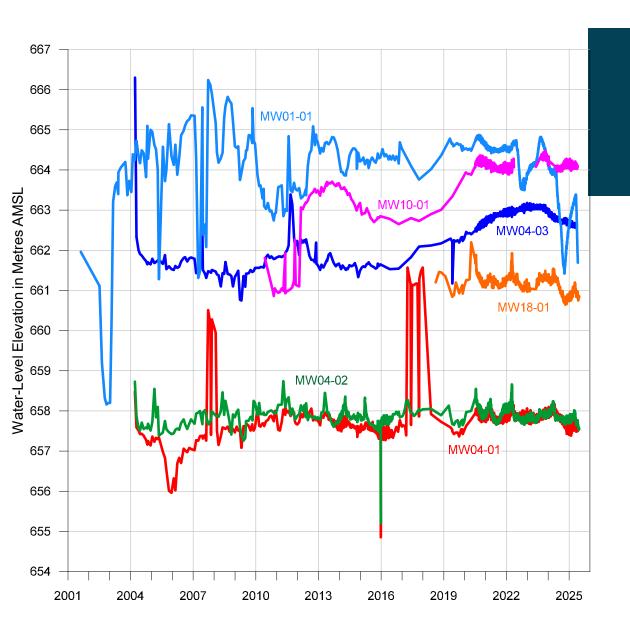
Water Levels Group 5

Water levels in Group 5 stable, except for MW01-01

Water levels are from natural fluctuations.

Fluctuating water levels in MW 01-01 are due to dewatering in the SW 21-054-026

W4M.

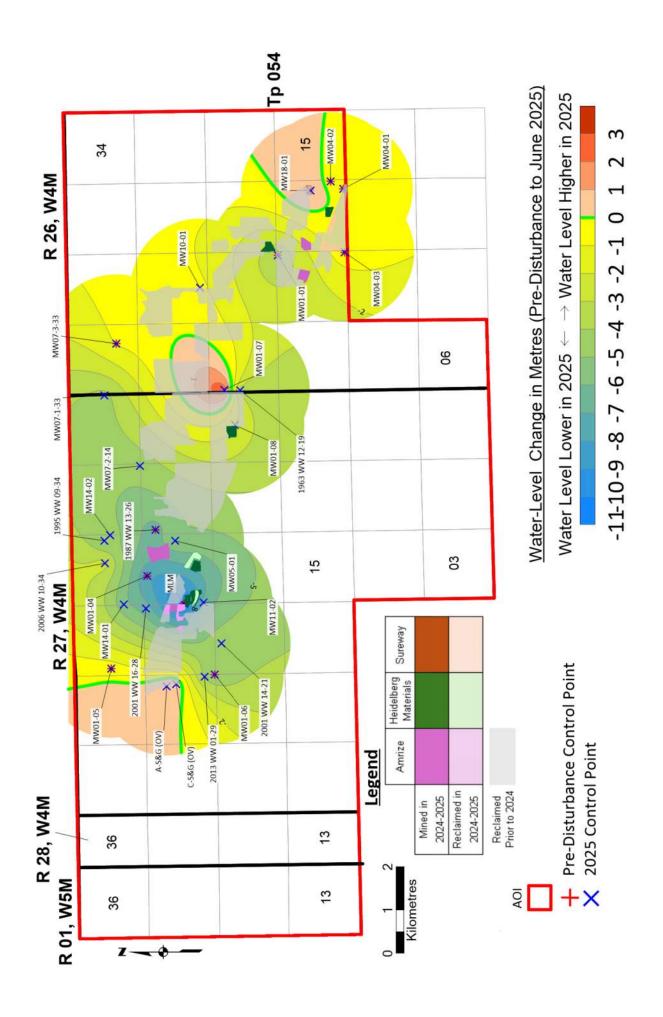
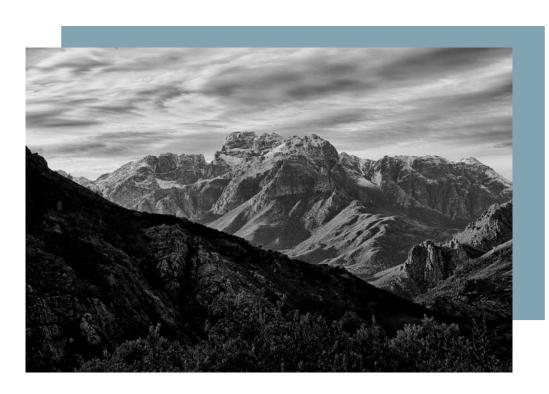
Water Level Trends

- Water-level decline is centered on active pits in the western part of the AOI.
- Mounding may result from the replacement of aggregate with less permeable material.
- Drawdown near active dewatering pits is approximately 4 to 9 metres.
- Water levels are expected to recover after dewatering.
- Full recovery may take several years.
- Not expected to adversely affect local groundwater users unless they are in close proximity to dewatering.
- Only shallow water wells are at risk of adverse effects.
