# INVESTIGATION REPORT

FIRE LOSS: MAY 3, 2025  
VEHICLE FIRE  
STURGEON COUNTY, ALBERTA

PROPERTY TYPE: 2025 OUTLANDER XMR 850

VIN: 3JB3WA645SJ001001

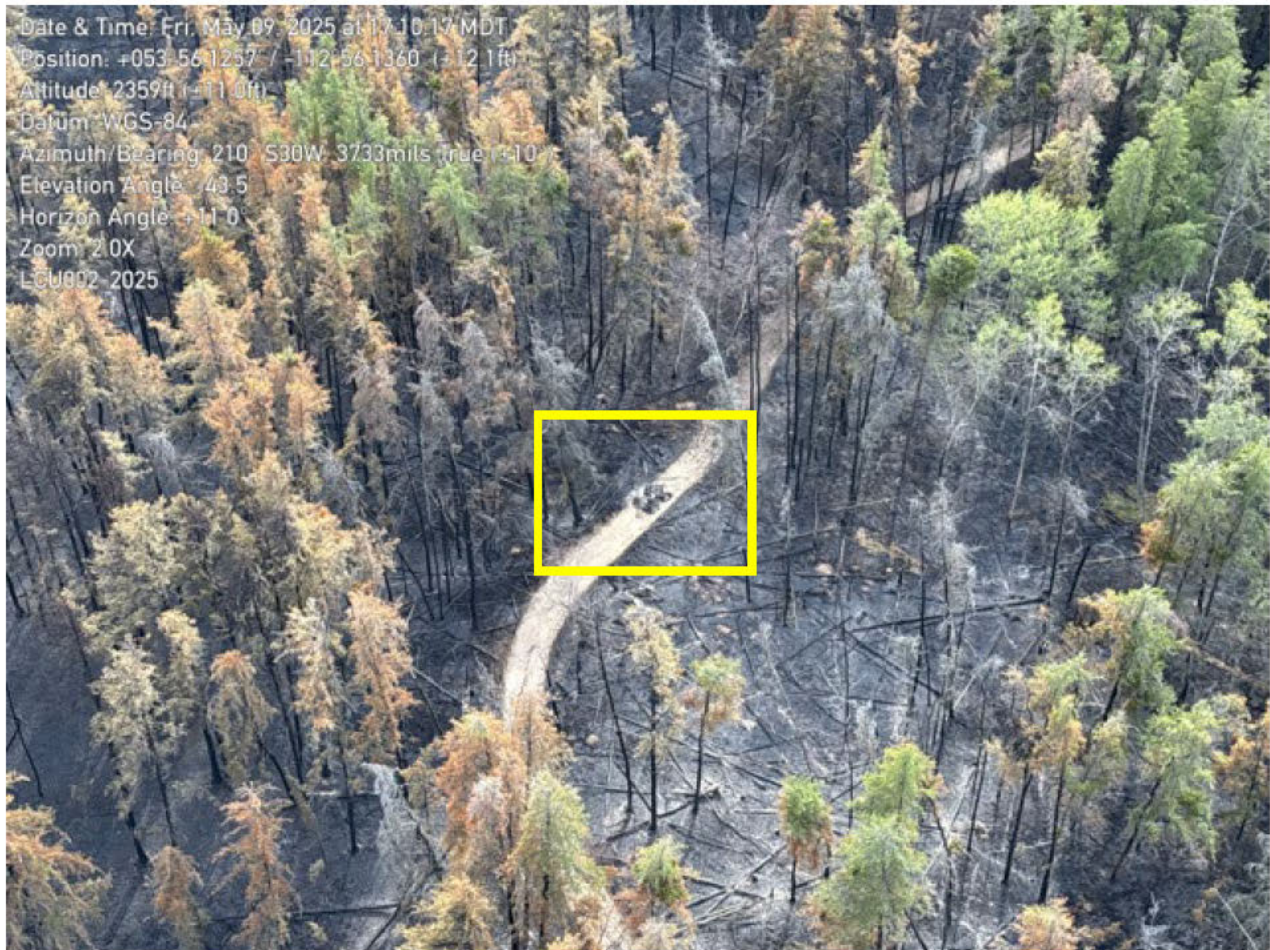
***FIGURE 1. FS2025-052, PHOTO COURTESY OF FIRE COMMAND OF THE ATV IN THE GENERAL ORIGIN AREA.***

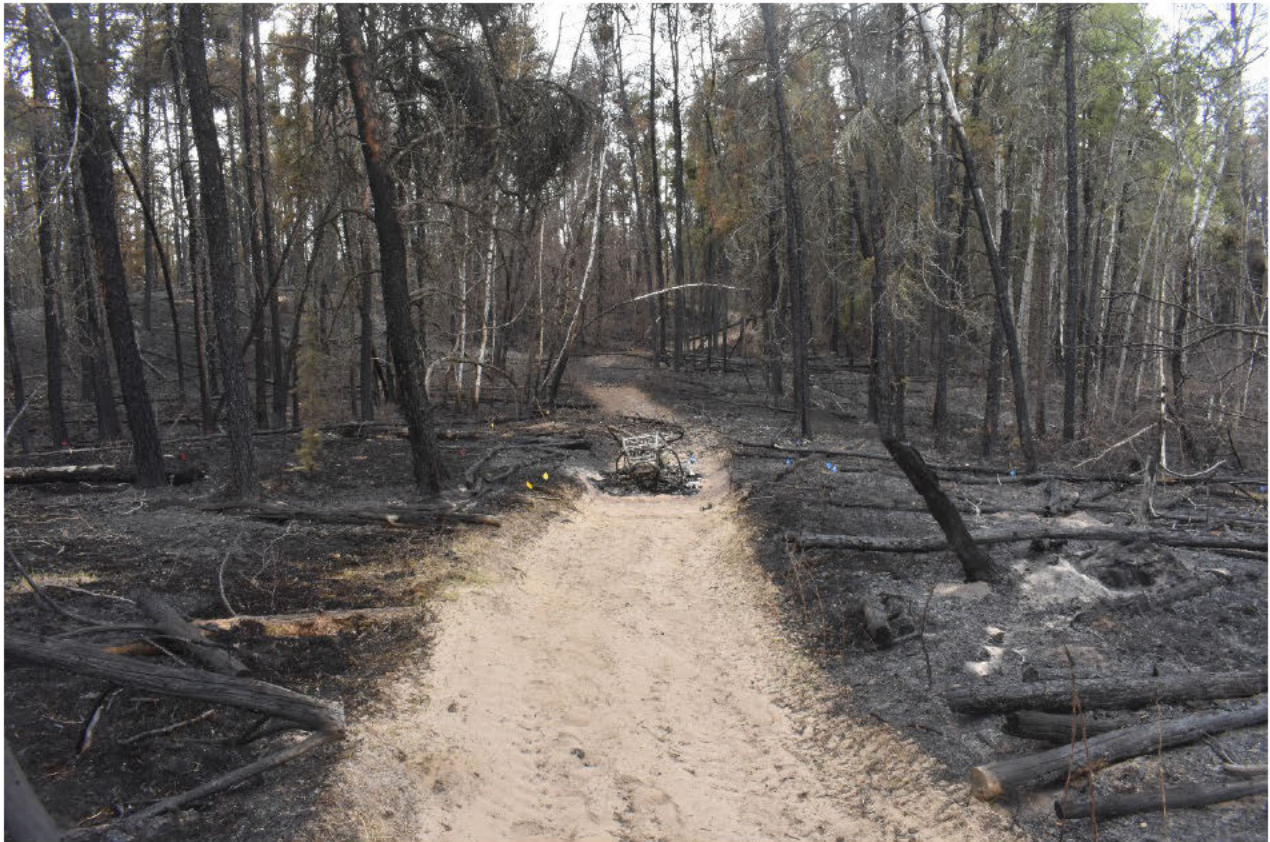
**FIGURE 3. FS2025-052 (2), PHOTO OF THE FIRE ATV IN THE GOA.**

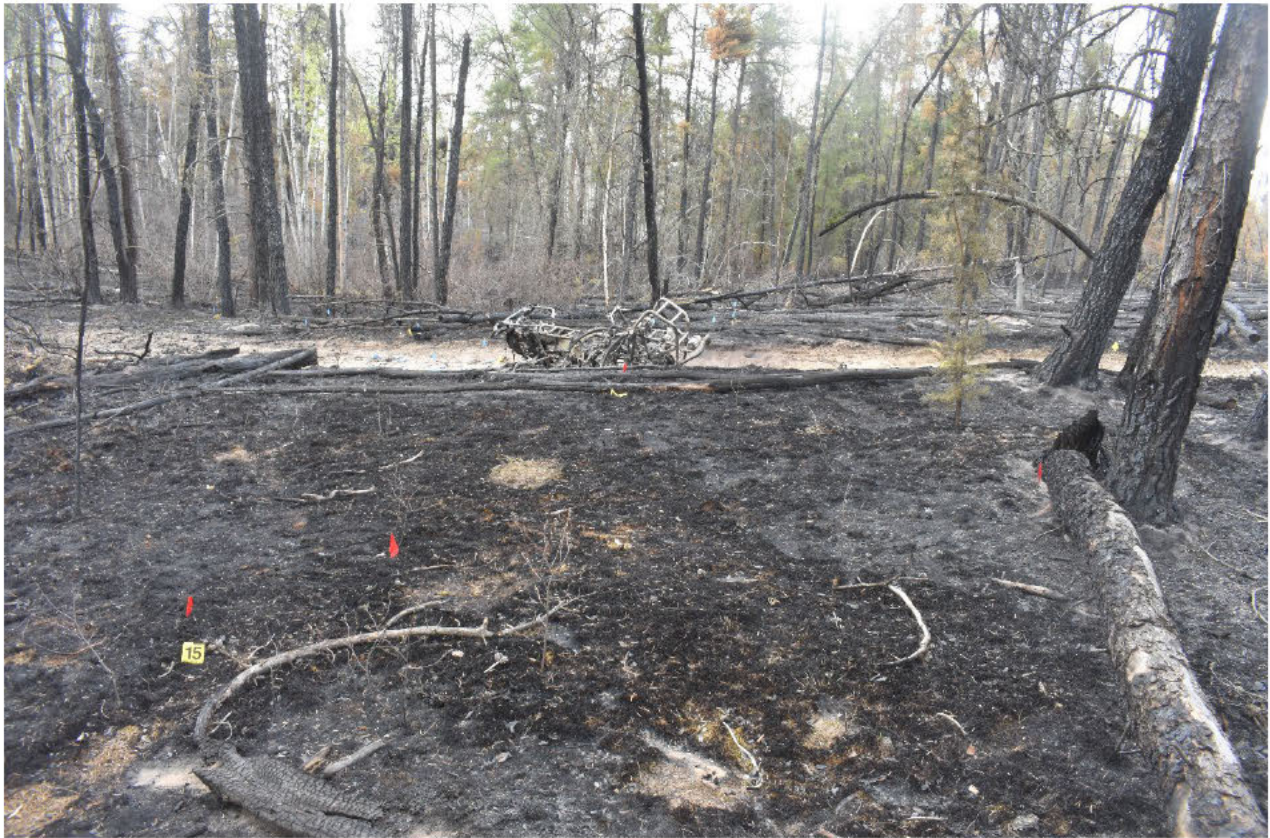
After completing the 360 in both directions to establish a General Origin Area (GOA), **COOK** and I then moved south of the trail to where there was well defined advancing fire, then walked from East to West. As we were walking from East to West we were identifying and marking macro and micro fire vector indicators. On the East flank of the GOA, we were able to define lateral indicators we then proceeded to the west marking advancing indicators and as we proceeded further West we were able to identify lateral indicators once again. Once we hit the lateral sections of these indicators we would then move north and then continue from West to East moving to the North every time we located lateral fire indicators. This process was done from the South side of the trail, including the trail and the North side of the trail. As we process the scene immediately North of the ATV we noted a significant amount of backing fire vector indicators. These backing indicators progressed for approximately 100 meters to the North. It then changed to advancing indicators. This has been corroborated with fire command reporting they had significant wind changes which would have change the fire direction travel. We placed multiple-colored flags in the ground. The red flags represent advancing fire indicators, the yellow flags represent lateral fire pattern indicators, the blue flags represent backing fire pattern indicators, white represents evidence, and green represents items of interest. We placed 12 red, 26 yellow, and 32 blue, this is a total of 70 indicator flags. Out of the 70 flags placed in the ground, we documented 21 indicators as the exemplars.

*FIGURE 4. FS2025-052 (38), PHOTO OF THE FIRE ATV IN THE SOA WITH ADVANCING INDICATORS IN THE FOREGROUND.*

After placing all the flags in the ground, we were able to determine through the fire pattern indicators that our Specific Origin Area (SOA) was a 2025 Outlander XMR.

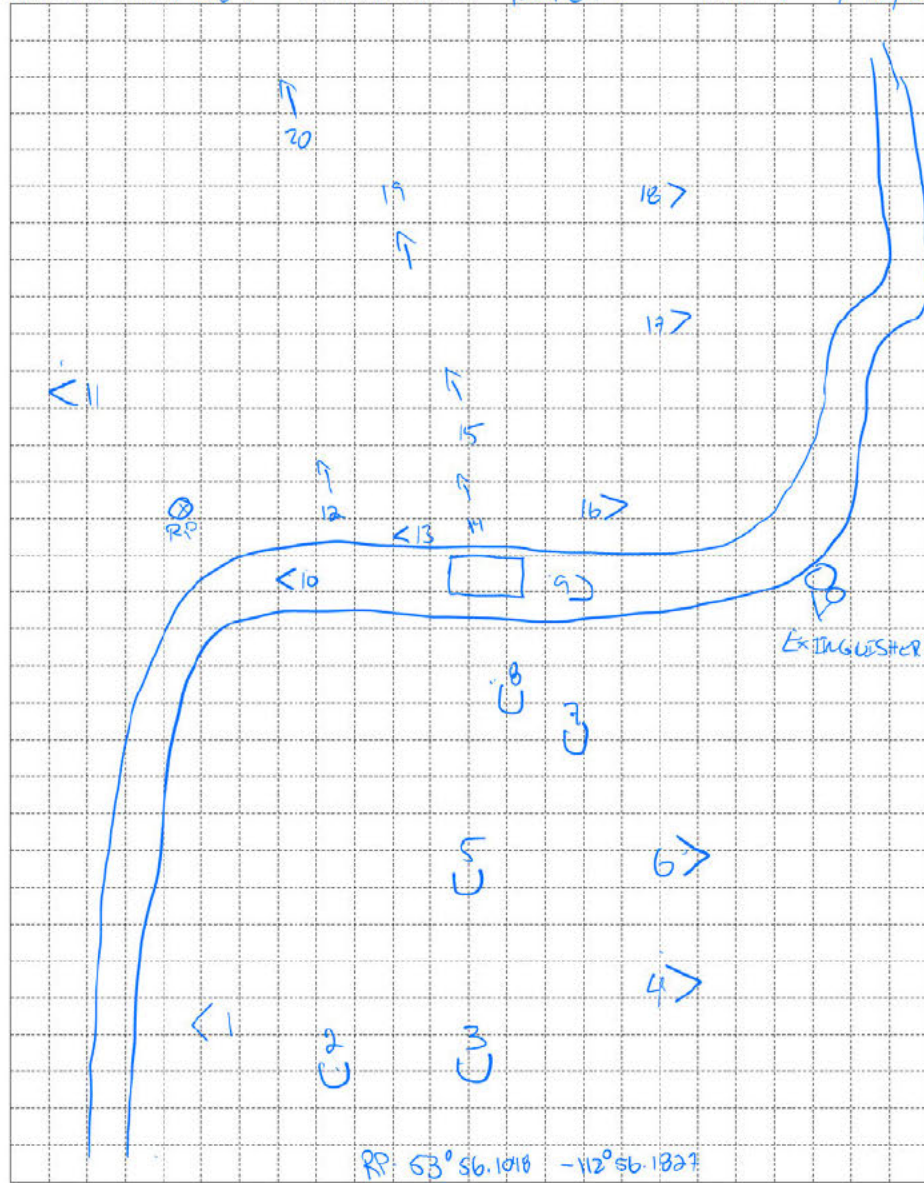
**SCENE SKETCH**

**FIGURE 5. FS2025-052, HAND DRAWN SKETCH (NOT TO SCALE) OF THE FIRE PATTERN INDICATORS WITH THE TRAIL AND ATV.**

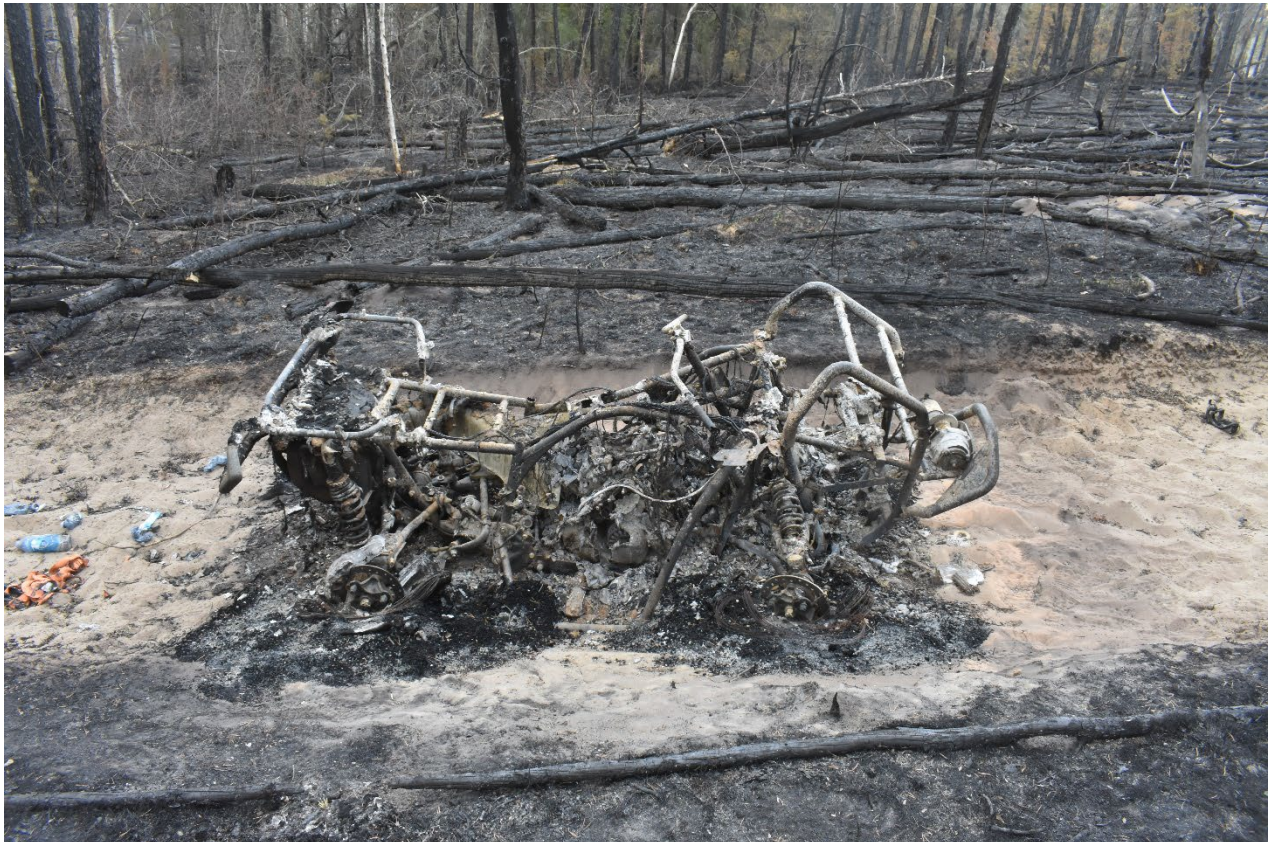
After determining the SOA, we then proceeded to process the ATV which was in the SOA. I noted the ATV was facing east on the east/west section of the trail.

*FIGURE 6. FS2025-052 (50), PHOTO OF THE ATV FACING EAST ON THE TRAIL.*

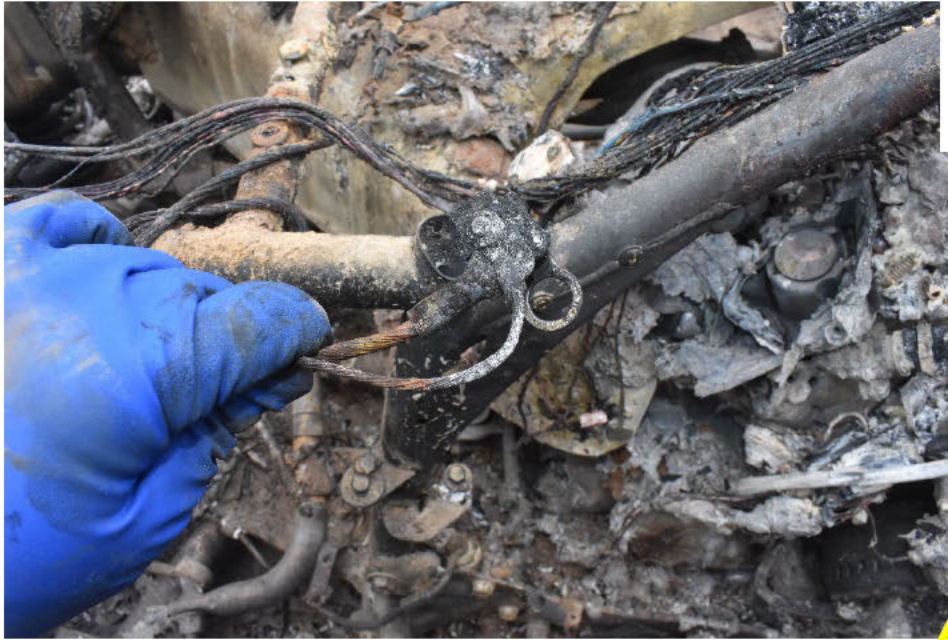
I noted all of the plastics and some of the aluminum had melted and were in hard piles on the ground. I then examined the exhaust system as it was possible this fire was caused by organic material being heated by the hot exhaust system. During our examination at the fire scene, I did not observe any organic material adhered to the exhaust system or heat shields. There was burned sand on the muffler of the exhaust system. The heat shields were also intact and not compromised in any fashion. I continued to examine the ATV; I traced the main electrical wiring as well as the main power cables for the front mounted winch. I did note there was evidence of arcing on the positive power cable battery connection. I also noted an arced heavy gauge wire coming from the battery.

*FIGURE 6. FS2025-052 (88), PHOTO OF ARCING ON THE BATTERY CONNECTION.*

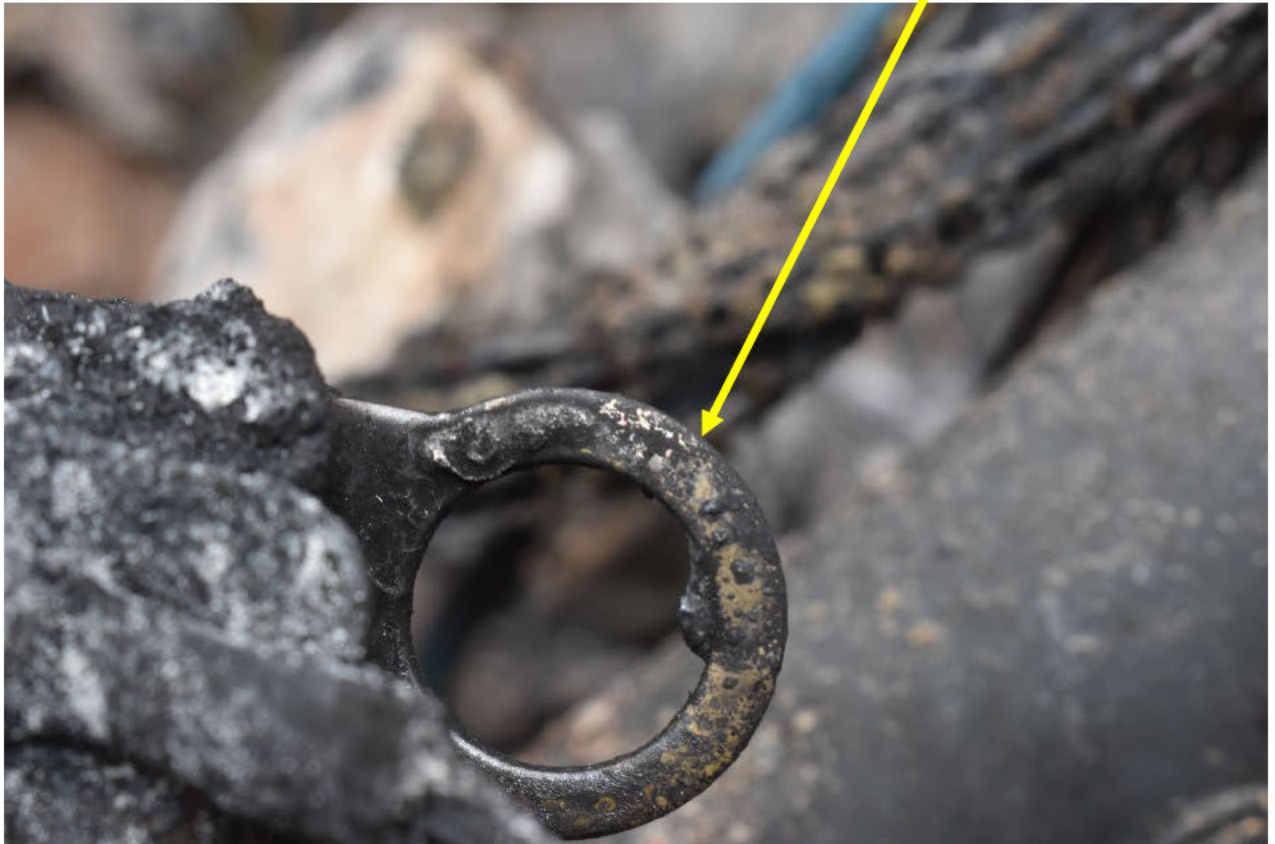
*FIGURE 7. FS2025-052 (89), BELOW, CLOSEUP PHOTO OF ARCING ON THE POSITIVE BATTERY CONNECTION.*

**It is highly probable this fire was caused by an electrical malfunction at the battery cable connections.**

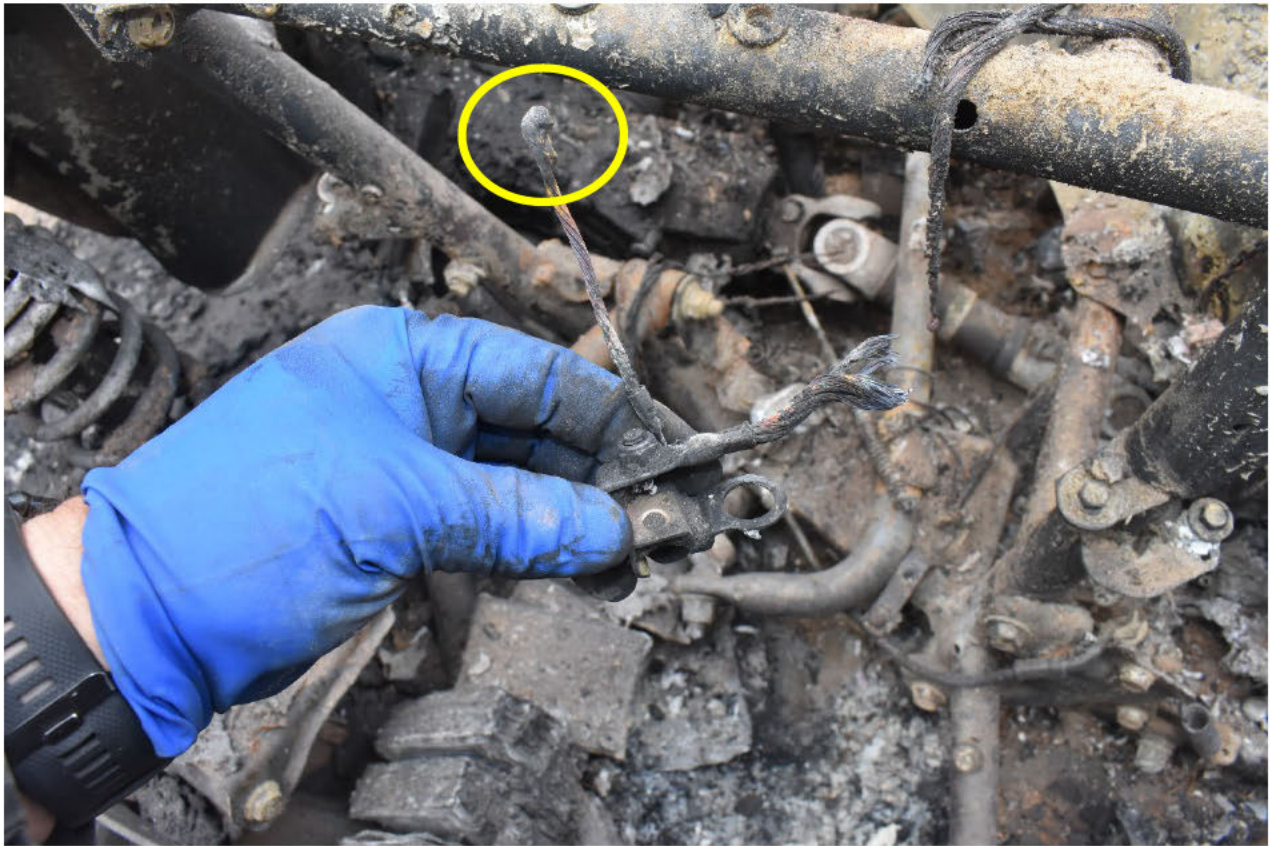
*FIGURE 8. FS2025-052 (90), PHOTO OF THE OTHER CONNECTION WIRING FOR THE BATTERY.  
NOTE THE ARC BEAD.*

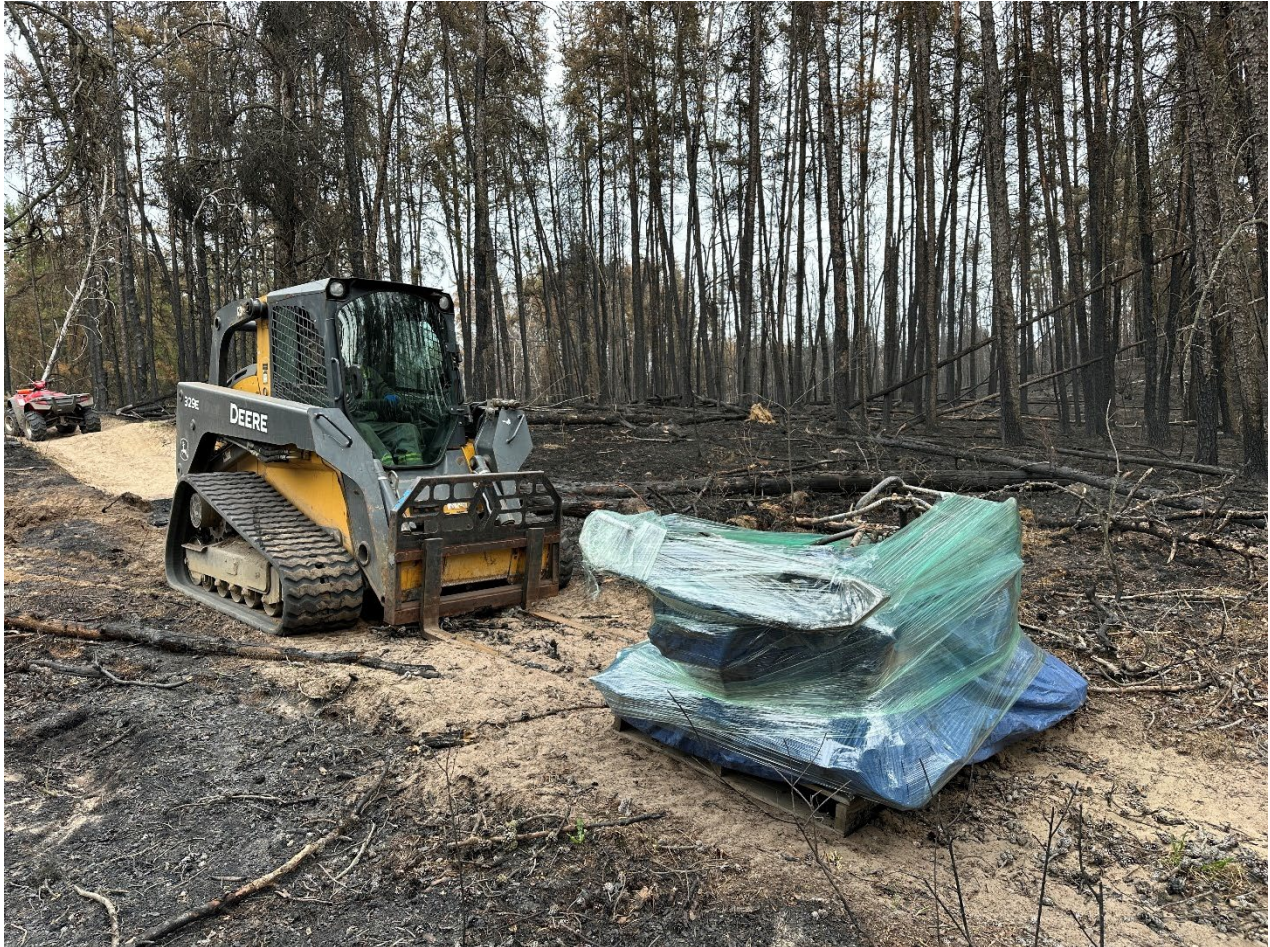
*FIGURE 8. FS2025-052 REMOVAL (9), PHOTO OF THE SEIZURE OF THE XMR.*

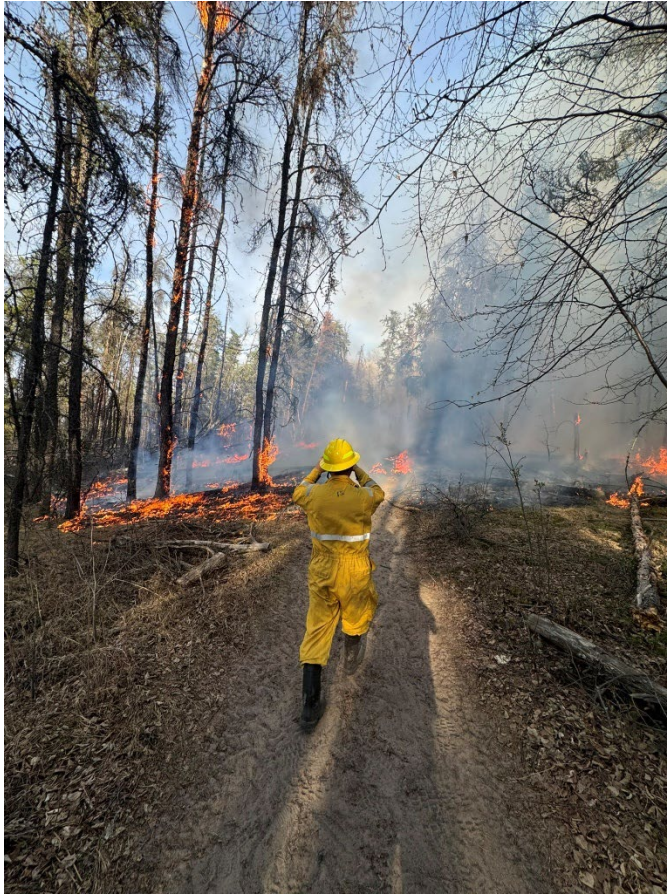
*FIGURE 12. FS2025-052 IMG\_2467, PHOTO PROVIDED BY **ATIA s.20**, FIRE CREW ARRIVAL WITH FIRE PROGRESSION.*
